# Garvey-Glenn Watershed Project

July 2014

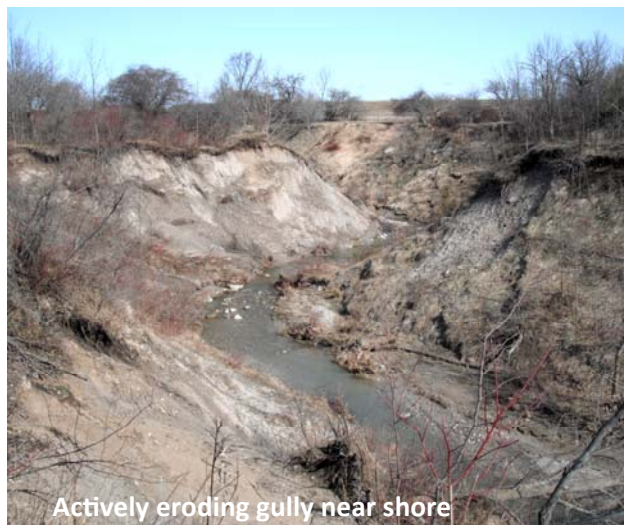
Actively eroding gully near shore

**Gully and Shoreline.** West of Kerry's Line, the north side of the gully has two active pastures and cattle are fenced out of the watercourse. The valley is forested but the vegetation has difficulty staying on the actively eroding slopes. According to landowners and historical aerial photos, the rate of the gully erosion has increased in recent years and the waterfall at the top end of the gully has been migrating upstream towards highway 21. The erosion poses a risk to private property, most notably the cottages along the creek at the shoreline. The Mid-Huron Beach Property Owners Association have been collectively installing drainage structures to convey water down the bluff to prevent bank slumping.

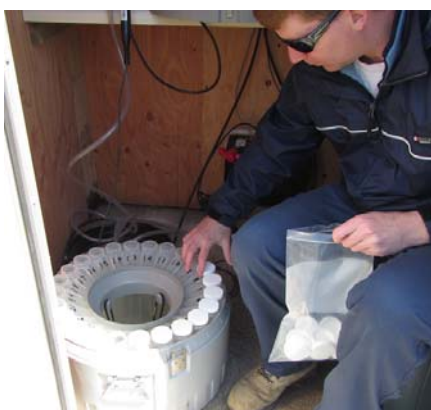
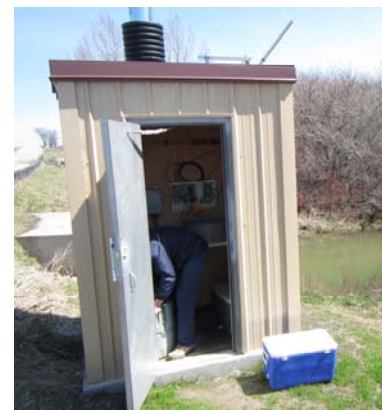
*This chart shows the variability in the concentration of phosphorus in relation to the flow for 2013, measured at the permanent monitoring station on Kerry's line.*

In 2012, a permanent water monitoring station was constructed on the south side of Garvey Creek on Kerry's Line. The station has an automated water sampler that is set up to take samples at regular intervals throughout flow events. This means we get a better understanding of how the concentrations of sediments and nutrients vary during different flow events throughout the year.

Between 2011 and 2014, concentrations of Phosphorus ranged between 0.003 to 1.4 mg/L, with the highest concentrations occurring during major flow events. For perspective, the provincial water quality objective for Phosphorus is 0.03 mg/L. Concentrations of Nitrates ranged from 0.05mg/L to 36.4 mg/L. 2.93 mg/L is the guideline for freshwaters in order to protect the health of life in and around rivers.

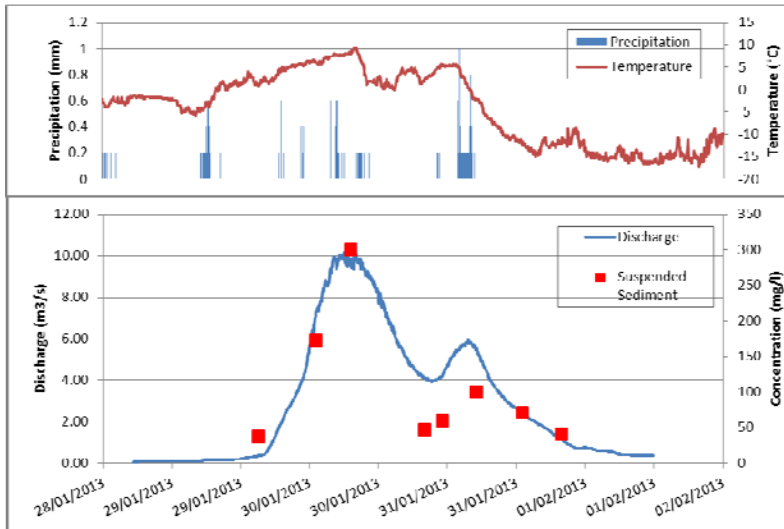
*In the example above, a snowmelt combined with rainfall resulted in a major discharge event late January 2013. Concentrations of suspended sediment vary throughout the storm and are related to the rate of discharge.*
