SCOTT MUNICIPAL DRAIN

Belgrave, Ontario (Nature Centre Road), Township of North Huron, Huron County

SCOTT DRAIN RGI FEATURES

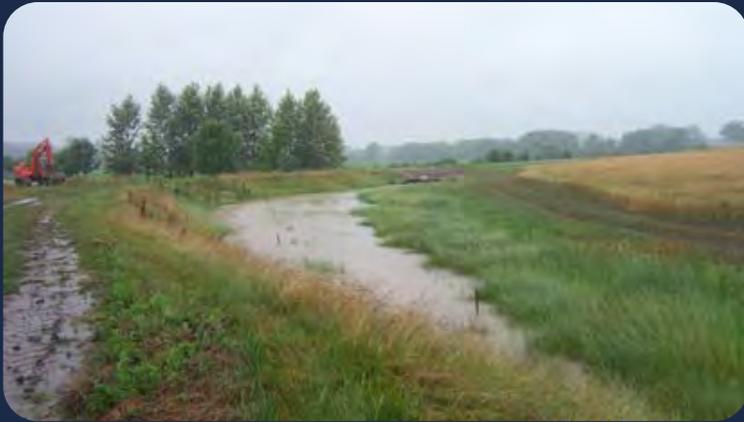
These berms intercept and hold back surface stormwater in order to direct it underground via french drain inlets and/or raised catch basins. Maintenance of these berms (including excess sediment and vegetation removal) is detailed within the drain report and is the responsibility of the drain superintendent. Special consideration was made to vegetate overflow spillways, to ensure that even if the berms were overtopped, some form of protection would be in place to reduce erosion and filter stormwater. Berm A is approximately 1.5 m in height and Berm B is 1.2 m in height.

Diversion Berm A and Wetland D

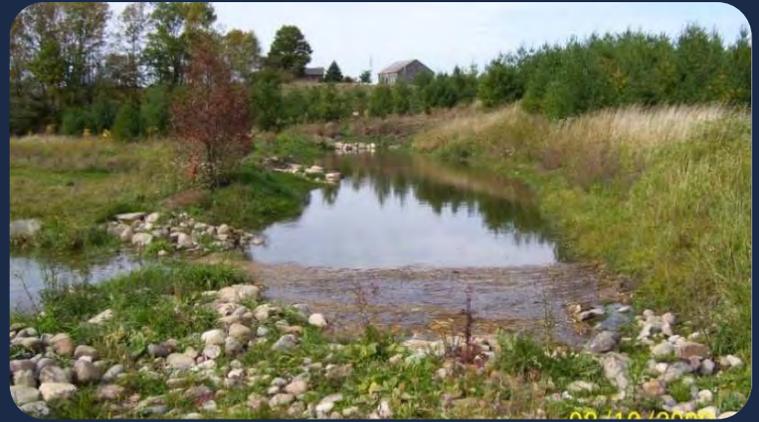
Diversion Berm B and Wetland F

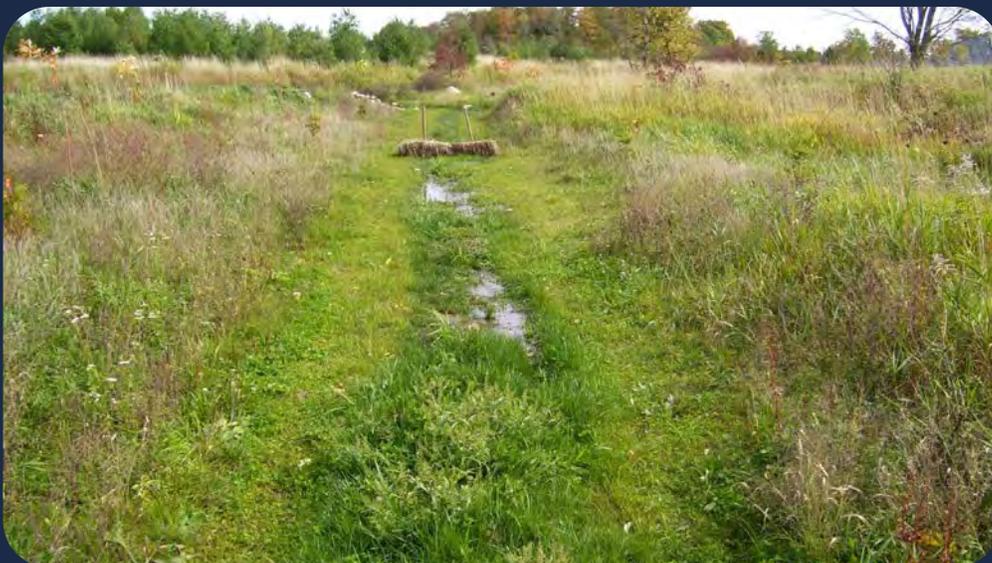
This feature provides a vegetated pathway for surface stormwater to travel to a stable outlet, in this case, Wetland F. The permanent vegetation in this area is protected within the drain report and cannot be converted to row crop production. The grassed waterway is 5 m in width and has been well-buffered with native shrubs and trees.

Grassed Waterway

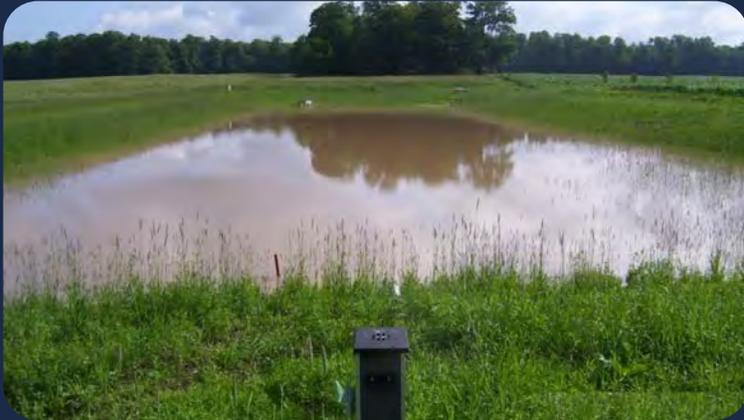
These features provide flood attenuation and sediment/nutrient filtering for surface runoff and subsurface drainage. Water retention of the wetlands is managed by flow control boxes, raised catch basins or overflow spillways. Maintenance of the wetlands are detailed and mandated in the drain report, with an emphasis on inlet maintenance and sediment removal to ensure proper functioning. The flow control box pictured below on Wetland A can be closed or restricted to allow retention of water and maintain levels in the wetland. Flow control can be adjusted throughout the year. The report recommends that outflow is left open during the winter and spring months and reduced during late spring and summer to maximize water retention in the wetlands during the summer months.

Wetland A with flow control box

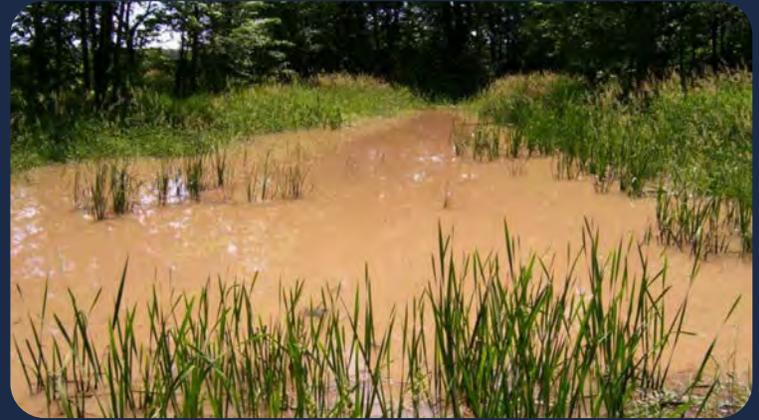
Wetland C filtering sediment

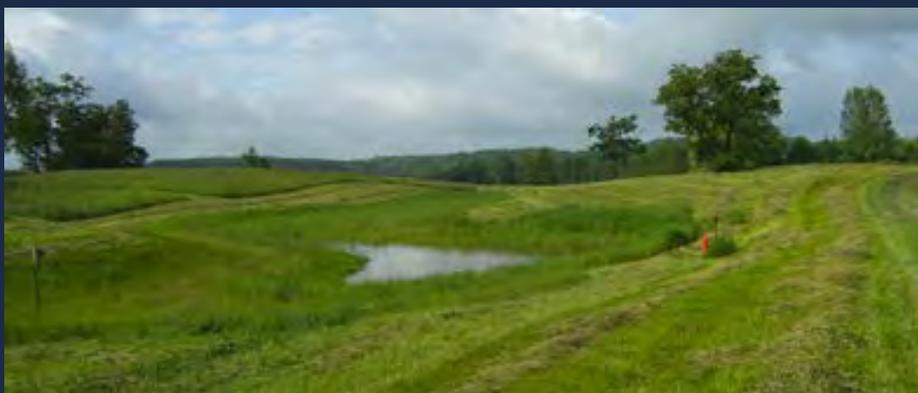
Alternatively, water height in Wetland B, pictured below, is controlled via a strategic overflow spillway. Although simpler in design, this static feature does not allow alterations to water height within the adjacent wetland. The total footprint for all six wetlands/retention ponds is 2.9 acres (1.2 ha). Each of the wetlands are well-buffered with permanent vegetation, including a variety of native grasses, shrubs and trees. These features provide semi-aquatic habitat and many ancillary benefits to wildlife in the area. The immediate 5 acres surrounding Wetlands A and B were established for hay production and cannot be converted to row crop production.

Wetland B with Raised Hickenbottom Outlet

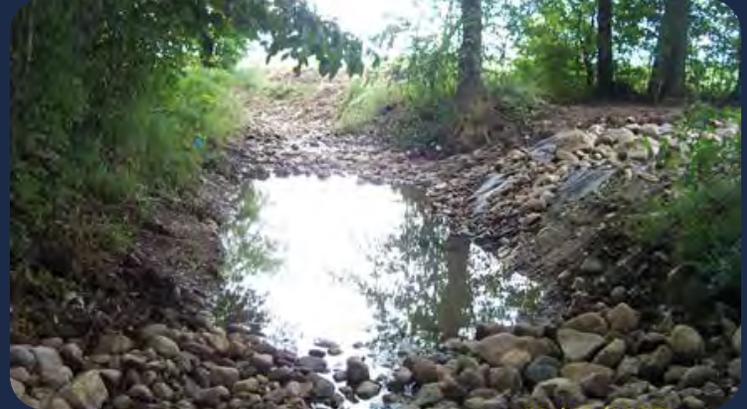
These features, sometimes called refuge pools, are basins within the open drain channel that accumulate/trap sediment that would otherwise flow downstream into the Blyth Creek. The basins are lined with rip rap stone to reduce the potential for erosion and provide a stable bed for sediment to settle onto. These basins also provide an offline pool for aquatic habitat.

The sediment basins are placed at strategic locations within the drain to ensure maximum functionality and allow for easier spot cleanouts in the future. Maintenance of these basins, including sediment removal and erosion protection, is detailed within the drain report. There are three sediment basins located within the drain, with each generally being 0.5 m long and 0.5 deep, with 1:1 side slopes.

Sediment Trap during low-flow

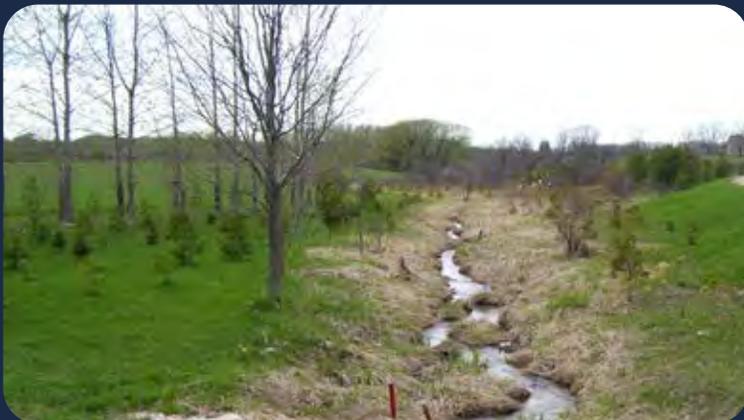
These features were planted along the open portions of the drain to provide structural stability to the drain. In certain locations, trees and shrubs will also provide help to filter excess sediments and nutrients from stormwater before it enters the open drain. Several different native species of grasses, shrubs and trees have been planted throughout the years by the landowner. In total, approximately 5.2 acres of riparian buffer was restored alongside the Scott drain. Many of these newly planted areas are detailed in the drain report and will be protected into the future. Alongside protection of these features, there is also special consideration within the drain report for the need to monitor vegetation in specific locations to ensure it does not negatively impact the functioning of the drain. For example, vegetation surrounding wetland D will be closely observed to ensure the french drain remains operable and does not become obstructed.

Riparian Buffer in 2007

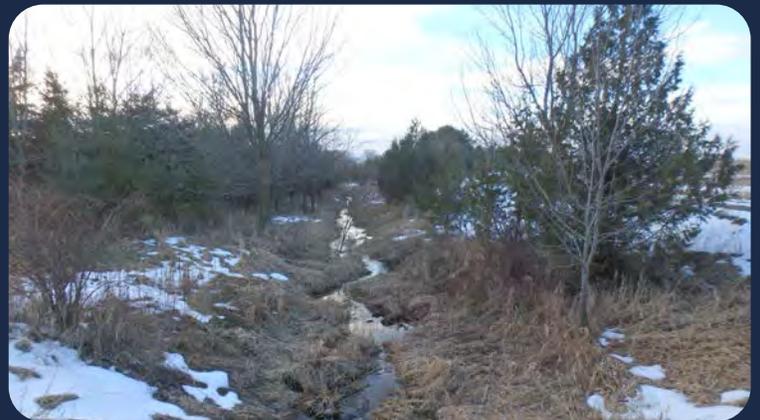
Riparian Buffer in 2018

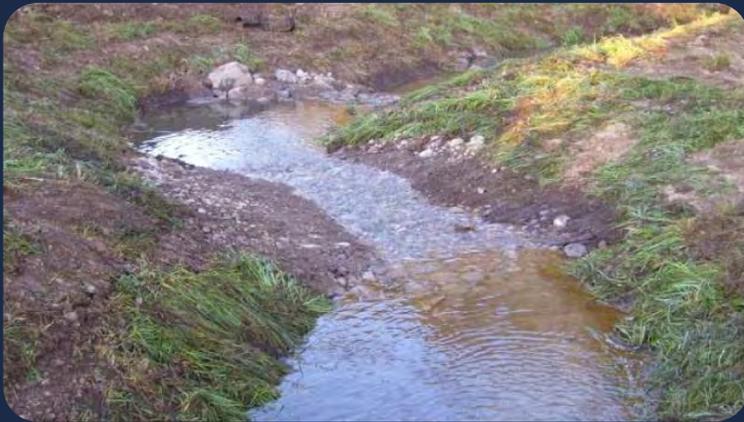
These features were constructed to initiate the development of a more natural open channel with improvements to aquatic habitat. Riffles are short segments of coarse gravel and rock substrate with turbulent, agitated flow. They are followed by pools, which are deeper basins that moderate water velocity and allow for sediment deposition. In the Scott drain, riffles and pools were constructed or improved upon at key locations within the drain to enhance existing habitat conditions. The profile of these structures is detailed within the engineered plans and will be maintained as such. Any repair materials (course stone, gravel, etc.) are detailed so that future maintenance will enable the continued functioning of these features.

Riffles and Pools post-construction

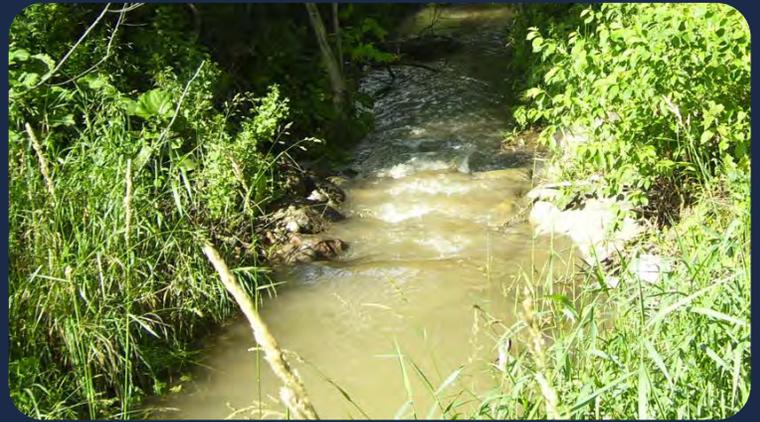
Riffles and Pools downstream

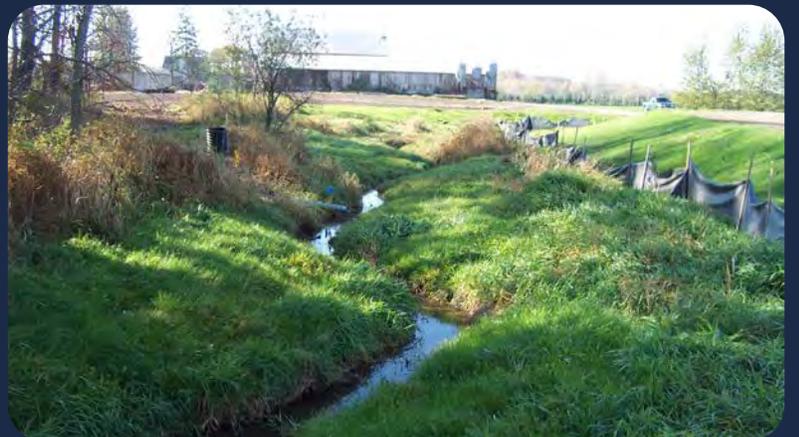
Certain midstream sections of the open drain were enhanced by creating a low-flow, meandering channel. This meandering channel has a variable channel width but is generally 0.6 m or less. High-flow events can still drain adequately via a gently-sloped bank to a channel with large bank widths. Where possible, the existing banks of the channel were left undisturbed and enhanced with native vegetation.

Natural Meander

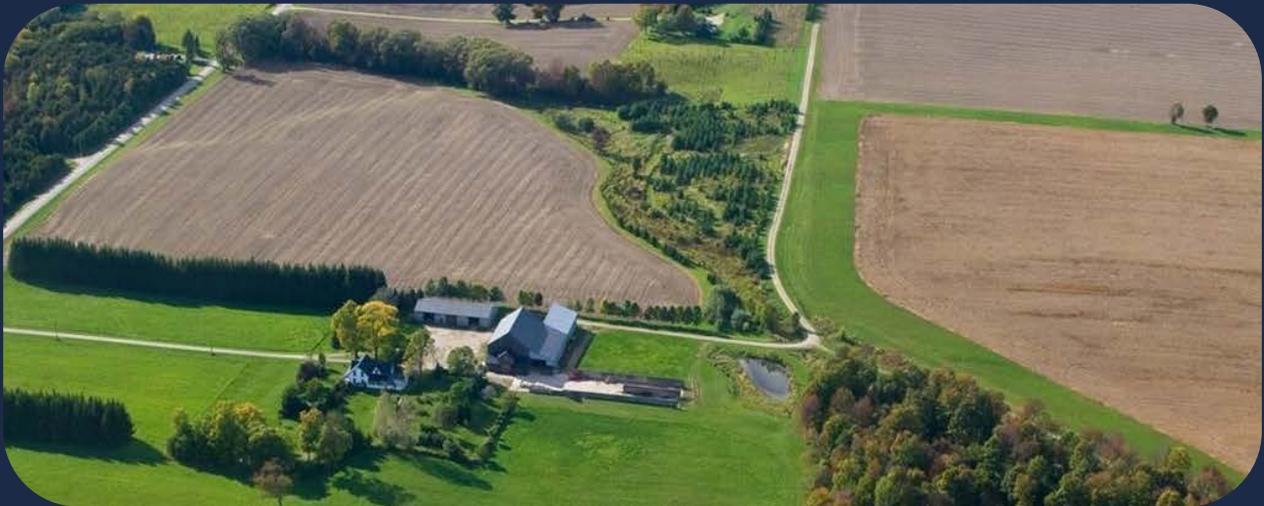
Overview of Scott Drain Features
